GROUP  
Engine

MODEL  
**Sedona, Sorento, Amanti,  
Optima, Rondo**

NUMBER  
**044 [Revised]**

ECM UPGRADE WITH TP SENSOR REPLACEMENT – MIL ON WITH DTC P2135 / P0638

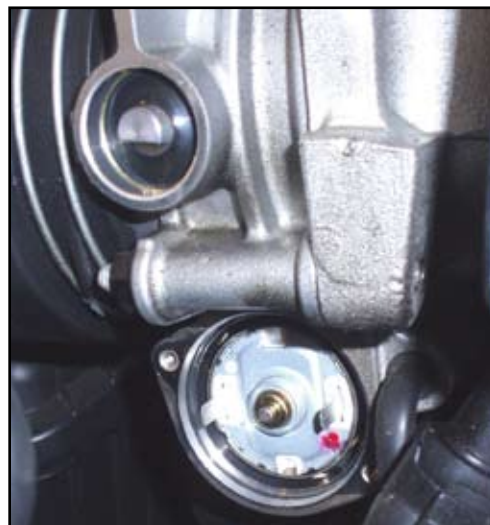
**The O-ring sometimes will stick to the housing during removal.  
Be sure to remove if this occurs.**

4. Remove the TP sensor from the ETC actuator.

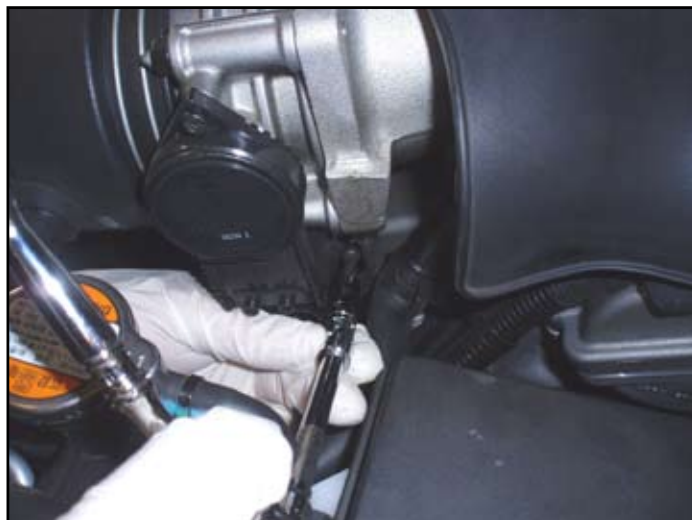
**On p/n 35107 3C100FF For 35107 3E100FF, the 4th hole is not used.**

2. Install the new TP sensor to the ETC actuator and tighten the Torx T-20 screws hand tight only. Use Loctite® Threadlocker Green 290 on screws during assembly.
